# Operating Experience Summary

## Office of Nuclear and Facility Safety

April 13 — April 26, 2000

Summary 2000-08

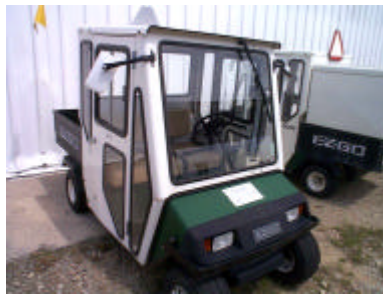
**Figure 1-1. E-Z-GO Tuff-One Utility Truck**

Investigators determined that Savannah River Site leases 210 E-Z-GO/Textron Tuff-One golf cars (see Figure 1-1) fitted with truck beds for use as utility vehicles. The 4-wheel utility trucks are based on an E-Z-GO golf car design using as many common parts as possible. They are powered by 11-horsepower Fuji 2-cylinder 4-cycle single overhead cam engines. The engine, battery, starter, alternator, and fuel tank are encased in a sheet metal enclosure mounted beneath a single bench seat. The Tuff-One vehicles are equipped with metal cabs and a fire retardant plywood and foam seat cushion. The engines do not idle. Depressing the accelerator pedal starts the engine and releasing it stops the engine. The throttle plate may not completely close if the accelerator throttle linkage and accelerator micro-switch are improperly adjusted. Maladjustment can allow gasoline to spit back into the paper cartridge air filter and the engine can backfire and ignite a fire.

An industrial forensic expert contracted by E-Z-GO performed an autopsy on the vehicle involved in the August 1999 incident in the presence of DOE and site contractor personnel. The forensic expert concluded that a combination of a dirty air cleaner and an engine backfire were responsible for the fire damage. A DOE engineer earlier had suggested that an electrical fault or short may have been the ignition source for the fire. The green 10 gauge-stranded wire appeared to have fused from the inside out about two inches from the positive battery terminal. E-Z-GO dismissed this theory, claiming that all of the electrical wiring was examined microscopically before the fuel system was examined, and nothing unusual was found. E-Z-GO/Textron will assume the cost of an industrial forensic autopsy for the utility truck that burned on April 6, 2000.

Enhanced preventive maintenance practices have been implemented for the entire fleet of trucks based upon the manufacturer's recommendations following the August 1999 autopsy. An E-Z-GO/Textron engineer supported Management and Operating contractor mechanics during initial implementation of the in-house maintenance program. Investigators believe that inspections and maintenance by the site contractor have been performed professionally. The maintenance history for the truck that burned on April 6 (see Figures 1-2 and 1-3) shows prior successful repair of a fuel problem. The contractor inspected twenty percent of the trucks since the first fire in August 1999, and found three or four that needed adjustment of the accelerator throttle linkage and accelerator micro switch.

Contractor mechanics recently found a paper air filter element in an E-Z-GO golf car with substantial scorching, clear evidence of the backfiring problem described by the manufacturer. During routine maintenance, air filter elements are frequently found contaminated with oil or gasoline a potential fuel source for a fire. Investigators also learned that E-Z-GO completely redesigned the air intake system in their 1997 models, moving the paper element away from the intake by several inches, adding two ninety degree turns, and two expanded metal screens. This considerably reduces the risk of fire from the paper air filter.

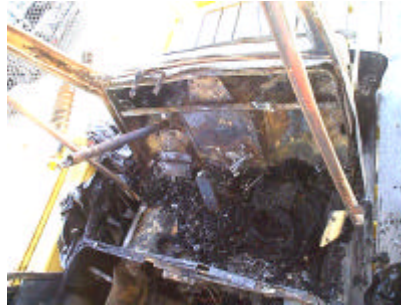
**Figure 1-2. Cab View of April 6 Event**

On April 6, 2000, at Savannah River, a Bechtel Savannah River Company construction employee attempted to extinguish a fire that consumed a gas-powered golf car utility truck that he was operating. The construction employee was not injured, but the utility truck was a total loss. Contractor management reported this fire because this was the second fire in their fleet of golf car utility trucks in 8 months. An unexplained generic fire risk can expose workers to unnecessary risk of serious injury. (ORPS Report SR--WSRC-CSWE-2000-0009)

Intensive efforts are underway at the site to determine the exact cause of the problem and to implement appropriate corrective actions. The wiring harness routing of an E-Z-GO golf car typical of the two that have burned was examined in detail. The harness sheath showed signs of abrasion where it passed through a horizontal oblong hole punched in the golf car frame directly under the passenger seat. The wiring harness is bound in a woven sleeve of tough nylon to resist casual abrasion. In an experiment with a hole of similar geometry and an unused wire harness for this model golf car, an engineer was able to cut through the nylon sleeve and wire insulation in about 8 seconds

of a sawing motion under pressure, creating direct contact with the conductor inside. The experimenters speculated that after hundreds of hours of rough service in the vehicle this mechanism might result in an electrical fire. Investigators intend to examine the golf car utility truck that burned in August 1999 for evidence of high current and burning at the frame penetration area. If found, this would provide direct evidence of an electrical fire source and a basis for mitigation action for the entire fleet. This area on the golf car cab could be checked for electrical harness wear during routine preventive maintenance and servicing.

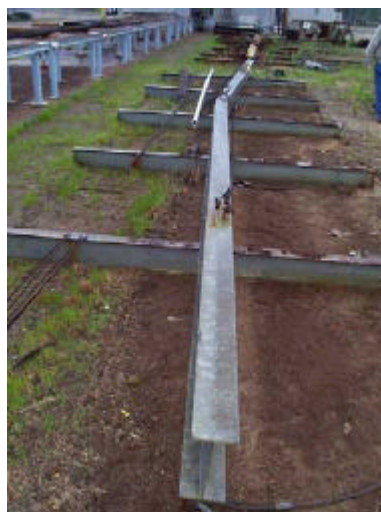
**Figure 4-1. Failed Spreader Beam**

On April 13, 2000, at Savannah River, a seven-ton spreader beam bent at its central point when a crane operator attempted to lift rebar scraps from the ground using two of the four beam lifting points. When the beam failed before it left the ground, the crane operator discontinued the lifting procedure and alerted facility management who placed a moratorium on spreader beam operations and started an investigation. There were no injuries associated with this event and there was no damage to equipment other than the spreader beam. Lifting heavy objects can cause personnel injury and equipment damage when capacities are not accurately calculated and procedures are not properly implemented. (ORPS Report SR--WSRC-CMD-2000-0008).

Investigators determined that the spreader beam is more than twenty years old and that its capacity rating does not meet the requirements in the Savannah River Hoisting and Rigging Manual. They determined that the crane operator used the spreader beam's two innermost lifting points to hoist the rebar load, rather than all four available lifting points. Investigators determined that the rebar scraps were somewhat shorter than the usual length and that the crane operator rigged the spreader beam thinking that the two innermost lifting points would handle the load. Figure 4-1 shows the failed spreader beam.

This event has prompted facility management to check all site hook-rigging devices dating back to 1990. The site construction rigging authority has discontinued the use of "below-the-hook" rigging devices until they all comply with Savannah River Hoisting and Rigging Manual requirements.

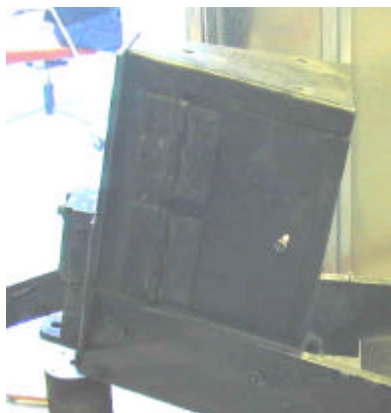
**Figure 8-1. Crystal Spectrograph Soft X-ray Diagnostic Assembly**

The diagnostic assembly (Figure 8-1) is a lead-shielded experimental chamber containing a crystal spectrometer. The top plate of the lead assembly (Figure 8-2) is two inches thick with three  $\frac{3}{8}$ -inch diameter threaded holes that are 0.54 inch in depth. Each hole has a lifting eyebolt screwed into a threaded key insert (Figure 8-2). The investigators determined that one of the eyebolts had pulled from its hole and found that the other two eyebolts came out with ease.

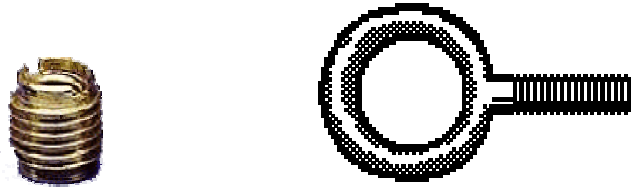
**Figure 8-2.  $\frac{3}{8}$ " Threaded Key Insert and Lifting Eye Bolt**

Investigators discovered improper design was the likely root cause. Lead is a soft metal that is susceptible to fatigue failures in lifting operations. The investigation continues and the Operating Experience Summary will report on future findings.
